RECONNAISSANCE INVESTIGATION OF GROUND CRACKS ALONG THE WESTERN MARGIN OF PAROWAN VALLEY, IRON COUNTY, UTAH

REPORT OF INVESTIGATION 253
UTAH GEOLOGICAL SURVEY

October 2004

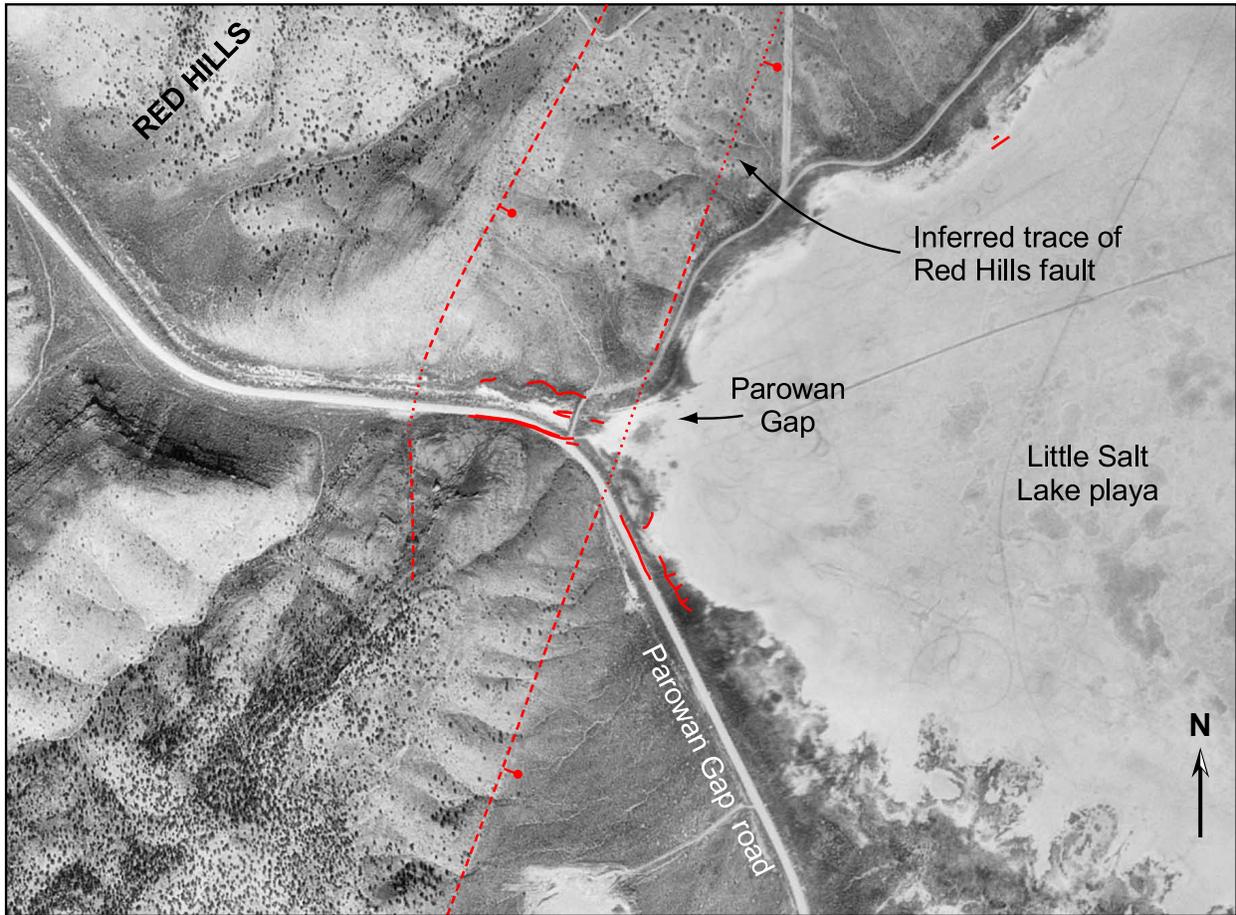
Figure 3. Ground cracks (solid red lines) along the western margin of the Little Salt Lake playa. Dashed and dotted red lines indicate the inferred location of the Red Hills normal fault; ball and bar on downthrown side (modified from Maldonado and Williams, 1993).

East of Parowan Gap, northwest- to northeast-oriented ground cracks and centimeter-to-meter-scale depressions parallel the western margin of the Little Salt Lake playa (figure 3). Along the southwestern margin, south of Parowan Gap, meter-scale cracks, 12-18 cm wide and up to 30 cm deep, parallel both the playa margin and a continuous hairline crack on the Parowan Gap road for approximately 150-200 m (figure 8). Also, short, polygonal, centimeter-scale tension cracks locally outline areas of gentle subsidence, and are eroded by surface-water flow and piping (figure 9). The northwestern playa margin is characterized by centimeter- to meter-scale cracks and an area of local subsidence about 12 m long by 6 m wide by 0.5 m deep, with the long axis parallel to the margin. South of the depression, a meter-scale crack has formed due to

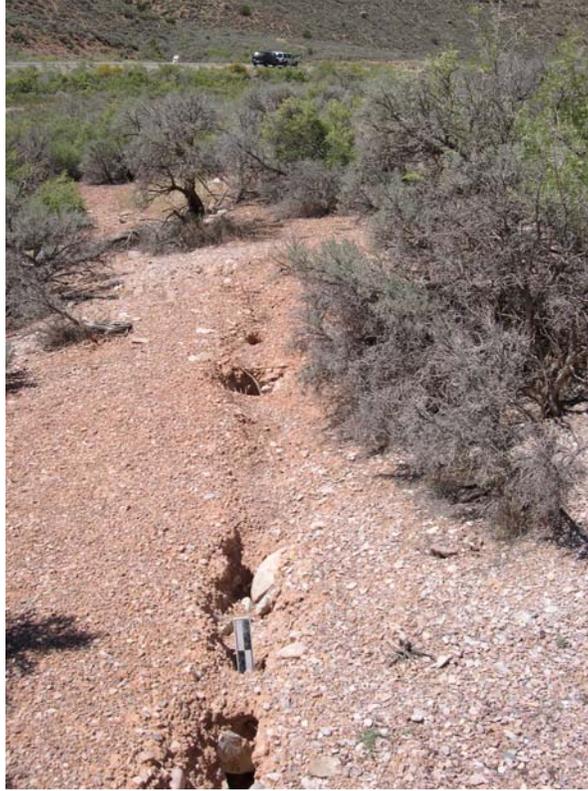
Along the northeastern part of Parowan Gap, east-west-oriented arcuate cracks extend across south-sloping alluvial-fan and hillslope-colluvium deposits (figures 4 and 5). Numerous small, disconnected depressions are aligned in an east-west direction, and are locally eroded by surface-water flow and piping, forming several 20-25-m-long eroded cracks and elongate depressions. The cracks have an en-echelon pattern and extend for a total of 124 m. Depressions range from less than 2.5 to 43 cm wide and less than 6 cm to about a meter deep, and most are about 15 cm wide by 30 cm deep, separated by 0.3-1.2 m (figure 5). The depressions commonly continue laterally below the surface along the trend of the crack, indicating active piping. No uneroded “hairline” cracks connecting the depressions were observed.

Figure 4. Ground cracks along the northern part of Parowan Gap. Part of scale visible in foreground is about 15 cm long (10 cm divisions). View is to the southwest.

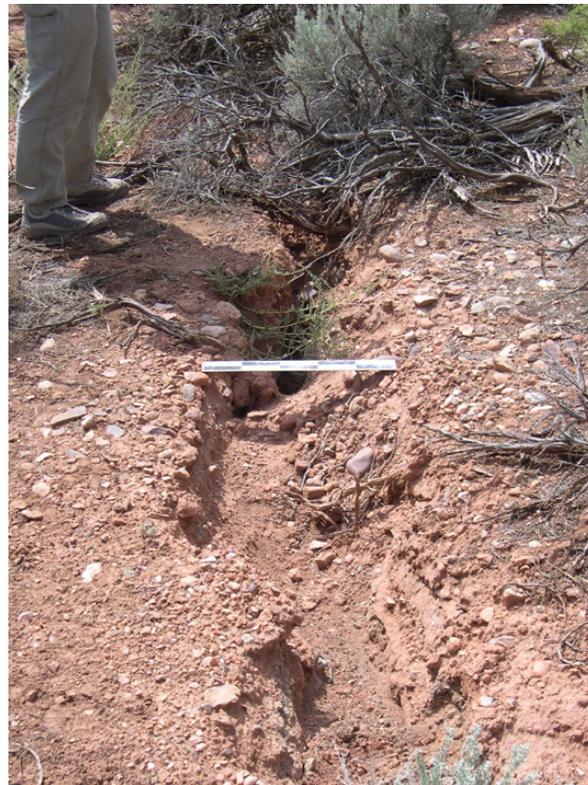
Figure 5. Ground cracks eroded by surface-water flow and piping. Scale is 50 cm long (10 cm divisions).

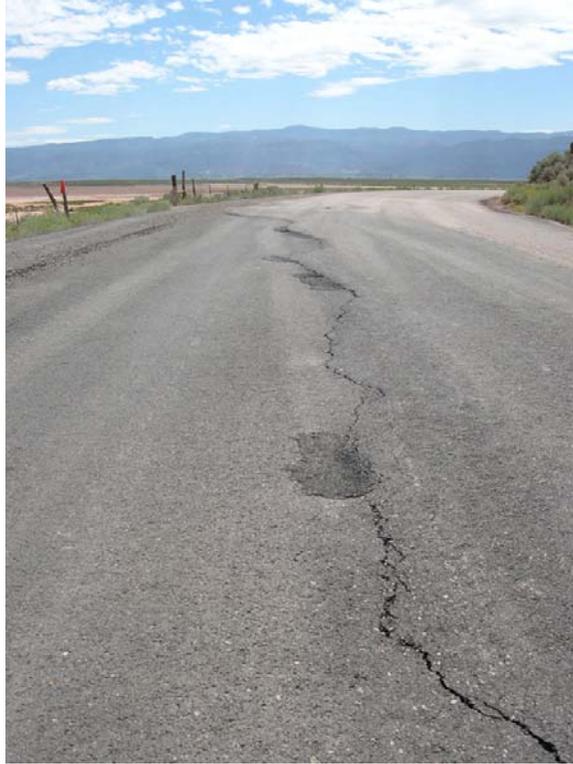
Along the southern part of Parowan Gap, sinuous, hairline cracks cut across the Parowan Gap road in an east-west direction (figure 6). The cracks are continuous, extend for 110-170 m, and locally form a narrow (about 1 m wide), shallow (less than 2 cm deep) symmetric graben. Collapse of the pavement indicates void spaces below the road surface, possibly due to piping of road construction materials (figure 7). According to the Iron County Road Department, damage to the Parowan Gap gravel road was first recorded in 1995, and hairline cracks were repaired shortly after the road was paved in 1998. About 35 m north of the road, ~45-m-long ground cracks and depressions extend in an east-west direction across playa deposits in the middle of Parowan Gap, normal to a north-south-oriented raised dirt road across the playa deposits (figure 3). The cracks are 10-20 cm wide and tens of centimeters deep due to erosion by surface-water flow; the closed depressions are up to a meter wide and tens of centimeters deep, and are possibly related to subsurface piping.

Figure 6. Hairline cracks along Parowan Gap road. Road patches indicate collapse of subsurface erosional pipes below the surface. View is to the east.

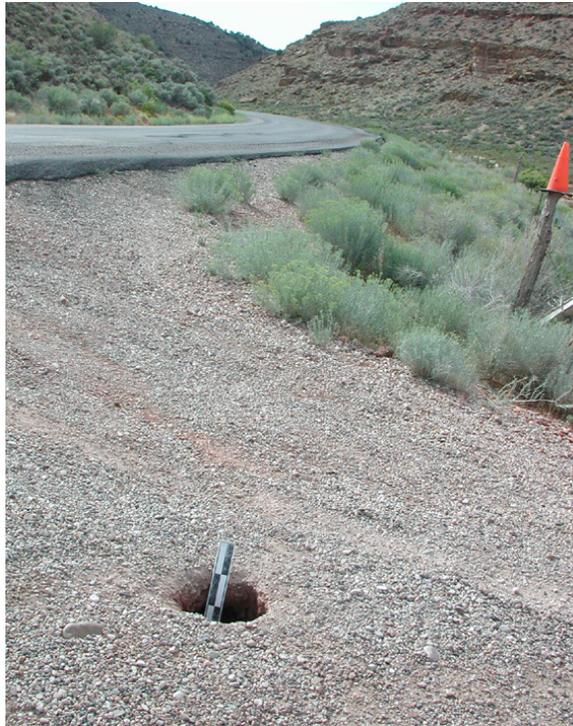
Figure 7. Evidence for piping below a dirt road, along strike of cracks on the Parowan Gap road (top of photo). Part of scale visible is about 20 cm long (10 cm divisions). View is to the west.

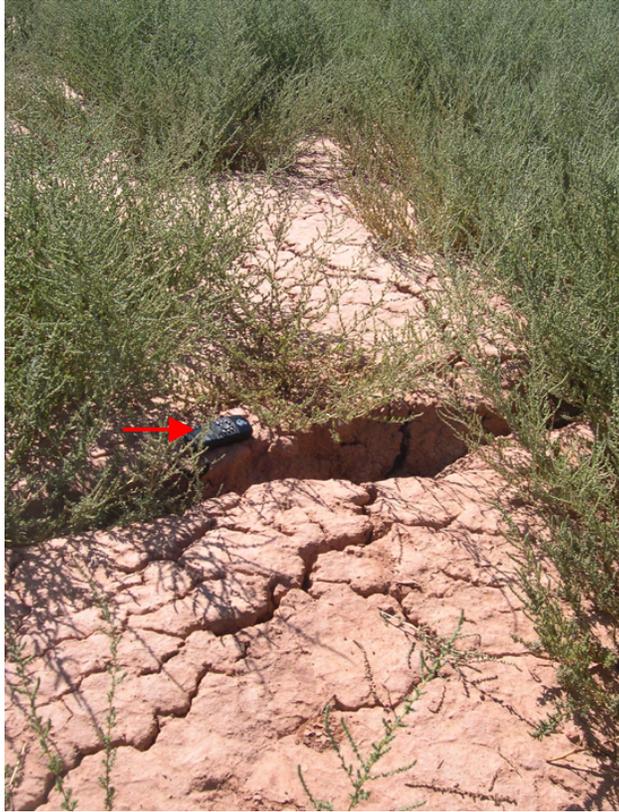
Figure 8. Ground crack (middle of photo) along southwestern playa margin, adjacent to centimeter-scale desiccation cracks (foreground). Hand-held GPS unit is for scale.

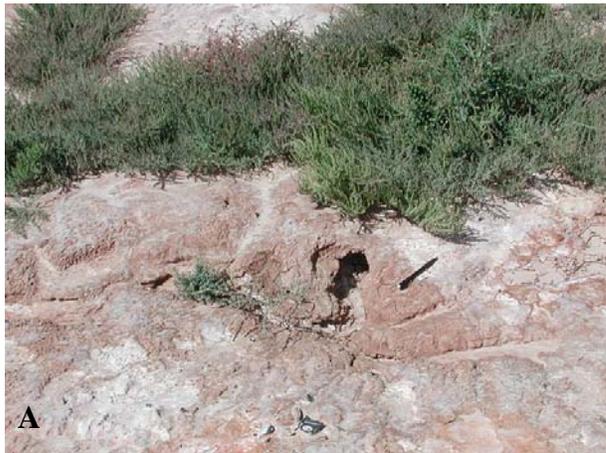
A

Figure 9. Eroded ground cracks along (A) the southwestern playa margin, adjacent to Parowan Gap (pen is for scale), and (B) the northeastern playa margin (crack is approximately 50 cm wide by 50 cm deep) (view is to the southwest).

surface-water flow and piping into an approximately 2.5-cm-wide uneroded crack in clay-rich sediments 15-20 cm below the ground surface (figure 9).
